When Crawlspaces Go Bad

By Daniel J. Kishchuk, P.Eng.

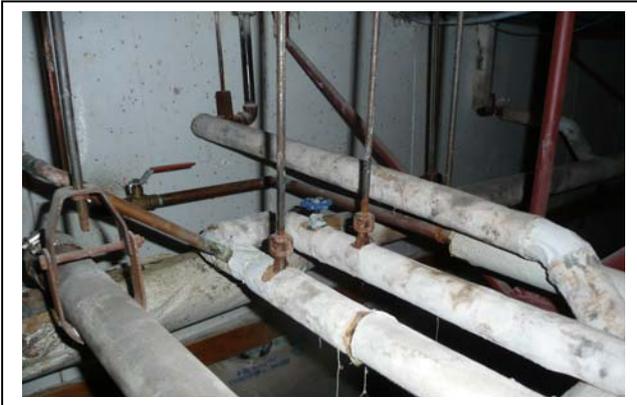
Photo 1. Mould growth on fabric jacketing due to high relative humidity in the crawlspace. As the relative humidity increased, the moisture content of the fabric increased to a level where mould spores on the fabric could germinate and colonize.

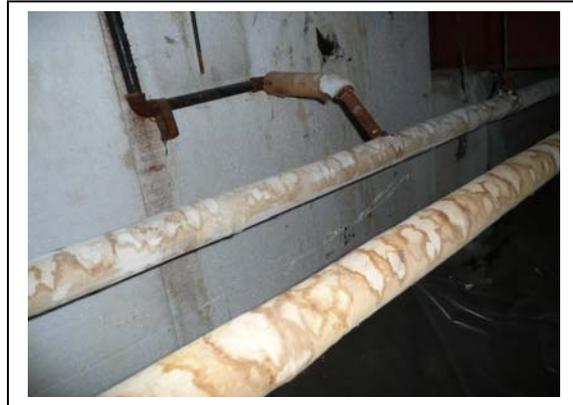
Photo 2. Staining on pipe insulation jacketing indicates condensate dripping from above. Note also the staining on the foundation wall insulation resulting from corrosion of the piping.

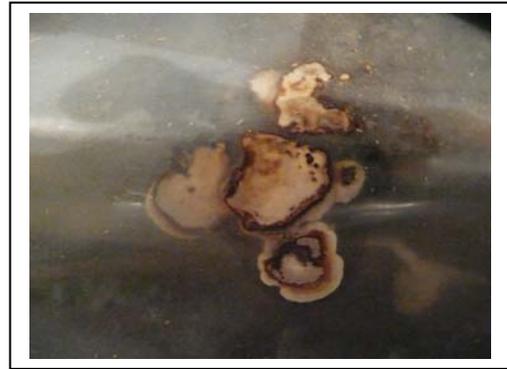
Photo 3. Fungi growing on a concrete footing beneath polyethylene ground cover material. The ground cover is resisting the ingress of moisture into the crawlspace as intended by the National Building Code of Canada. In the absence of moisture the fungal spores would not germinate and colonize.
